USACERL Technical Report M-90/09

Improved and New Roofing for Military Construction

Long Term Field Test Results of Experimental EPDM and PUF Roofing

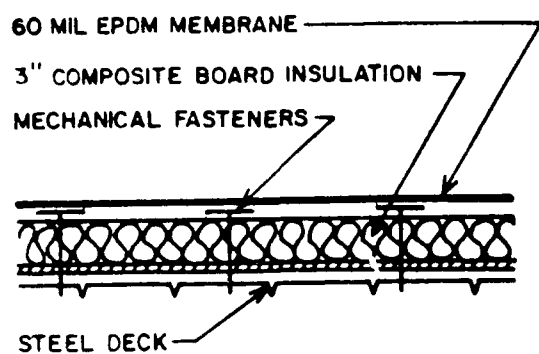
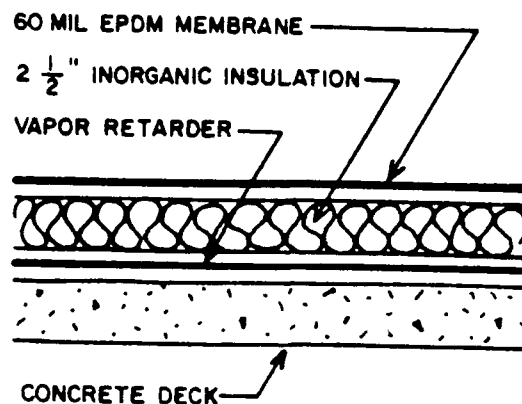
Figure 1. EPDM roofs, cross sections.

The system at Fort Benning consists of a fluted steel deck, 3 in.* of composite board insulation mechanically fastened to the deck, and 60-mil thick single-ply EPDM membrane. The system at Fort Lewis consists of a poured-in-place concrete roof deck, a one-ply vapor retarder of No. 43 asphalt-saturated and coated glass fiber base sheet installed in hot asphalt, 2-1/2 in. of rigid inorganic board stock with asphalt-saturated organic felt facer sheets installed in hot asphalt, and a 60-mil thick single-ply EPDM membrane. Figure 1 shows cross sections of the EPDM roofs.

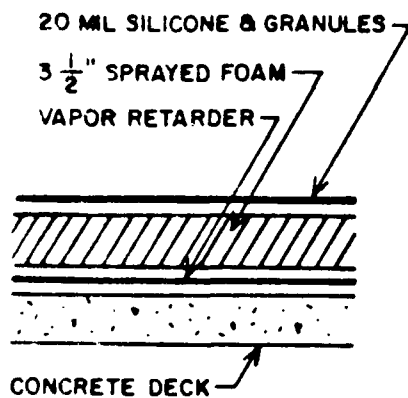
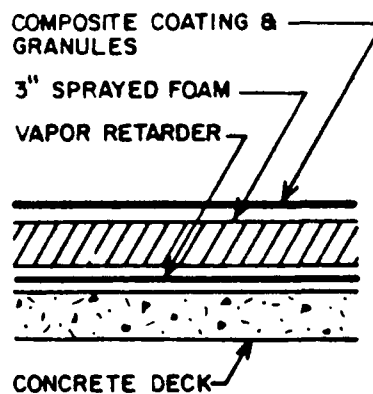
Figure 2. PUF roofs, cross sections.

The system at Fort Lewis consists of a poured-in-place concrete roof deck, one ply of No. 43 asphalt-saturated and coated glass fiber base sheet in hot asphalt, a minimum 3 in. of sprayed PUF, and a coating consisting of a base coat of a two-component polyurethane elastomer and a top coat of chlorosulfonated polyethylene with granules. The minimum thickness was specified as 20 mils but was actually determined to be 10 mils. Figure 2 shows the cross sections of those PUF roofs.

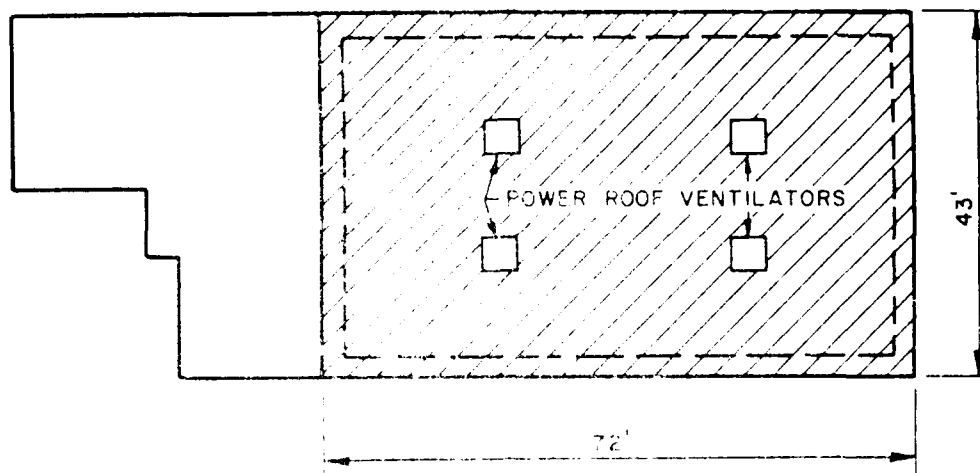
ROOF PLAN - BLDG 2823

Figure 3. Building selected for EPDM roofing at Fort Benning.

Figures 3 through 5 show the roof plans of the buildings selected for EPDM and PUF at Forts Benning and Lewis. Construction of these systems is described in *Construction of Experimental Roofing*.⁵

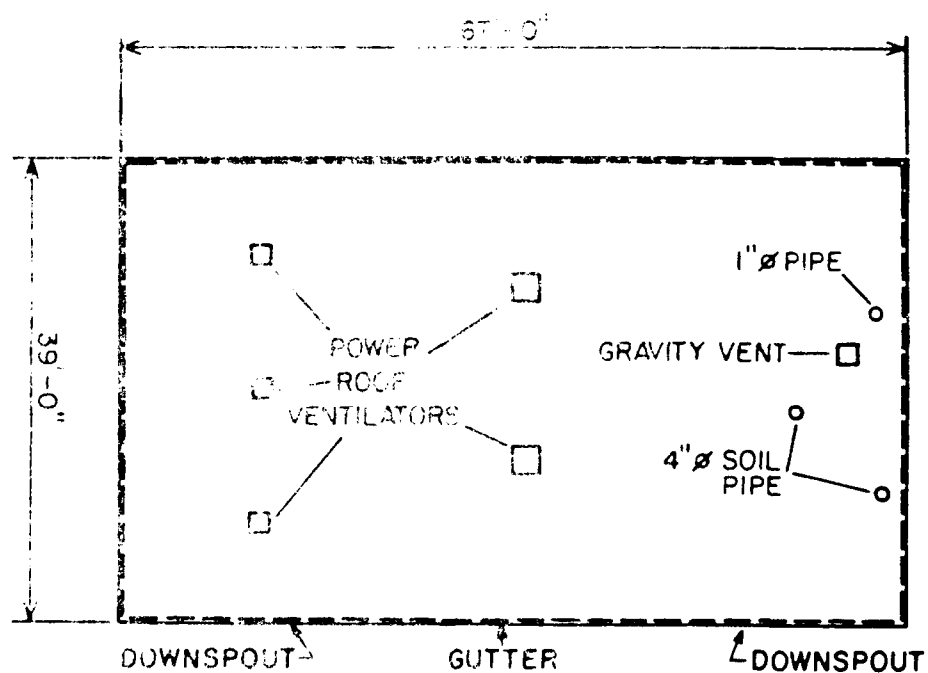
ROOF PLAN - BLDG 2806

Figure 4. Building selected for PUF roofing at Fort Benning.

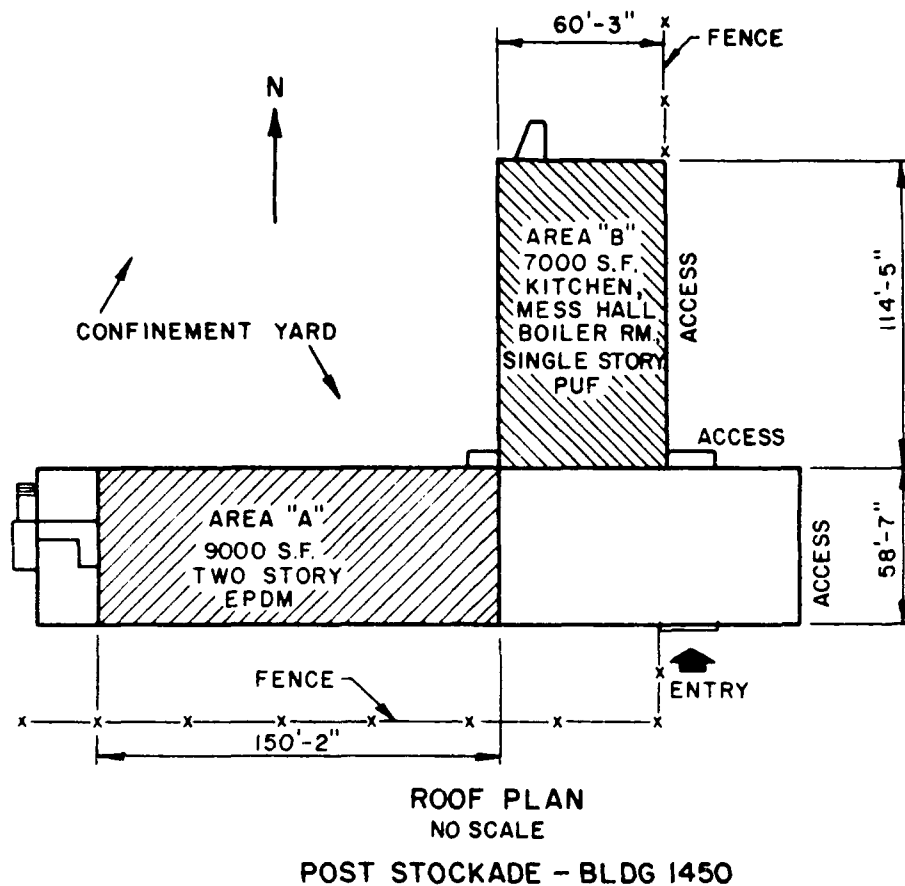
Figure 5. Building selected for EPDM and PUF roofing at Fort Lewis.

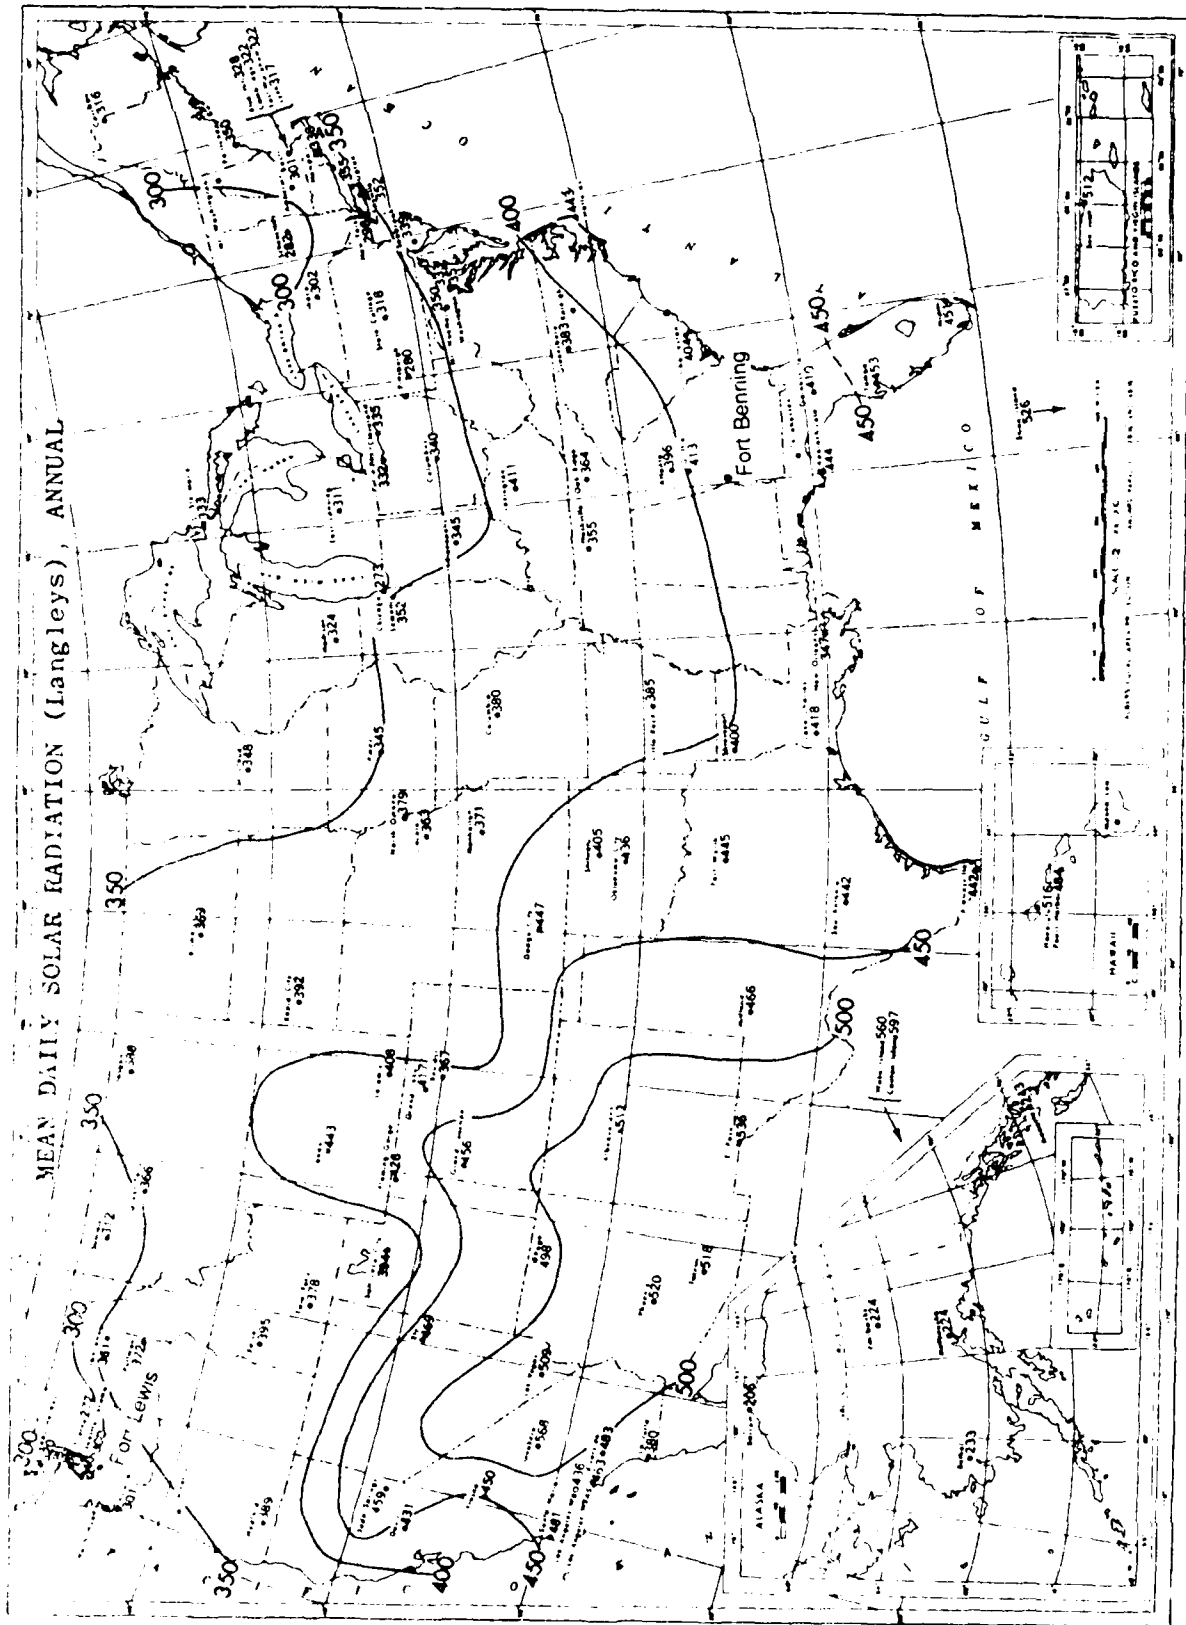
Figure 6. Mean daily solar radiation - United States annual.

Comparing the two locations, Fort Lewis has a relatively stable temperature range throughout the year, while Fort Benning has warmer temperatures in the summer and about the same temperatures as Fort Lewis in the winter. Fort Benning also averages more than twice the number of clear sunny days than does Fort Lewis (113 to 54). Fort Lewis averages more cloudy days (228 to 151). This results in a higher heat load and ultraviolet radiation on the roofs at Fort Benning, and the correspondingly higher roof degradation associated with the increased solar exposure. The mean daily solar radiation is about 413 Langleys at Fort Benning, compared to 300 Langleys at Fort Lewis (Figure 6). Fort Benning averages more than eight times the number of thunderstorms and associated severe weather than does Fort Lewis (58 to 7) and heavier annual rainfall, mostly in the summer. The rainfall and severe weather at Fort Benning is significant. The hot Georgia sun expands the membrane and flashing which then cools down and shrinks with the rain. Also, because the annual rainfall in Georgia is higher, more problems associated with ponding could occur.

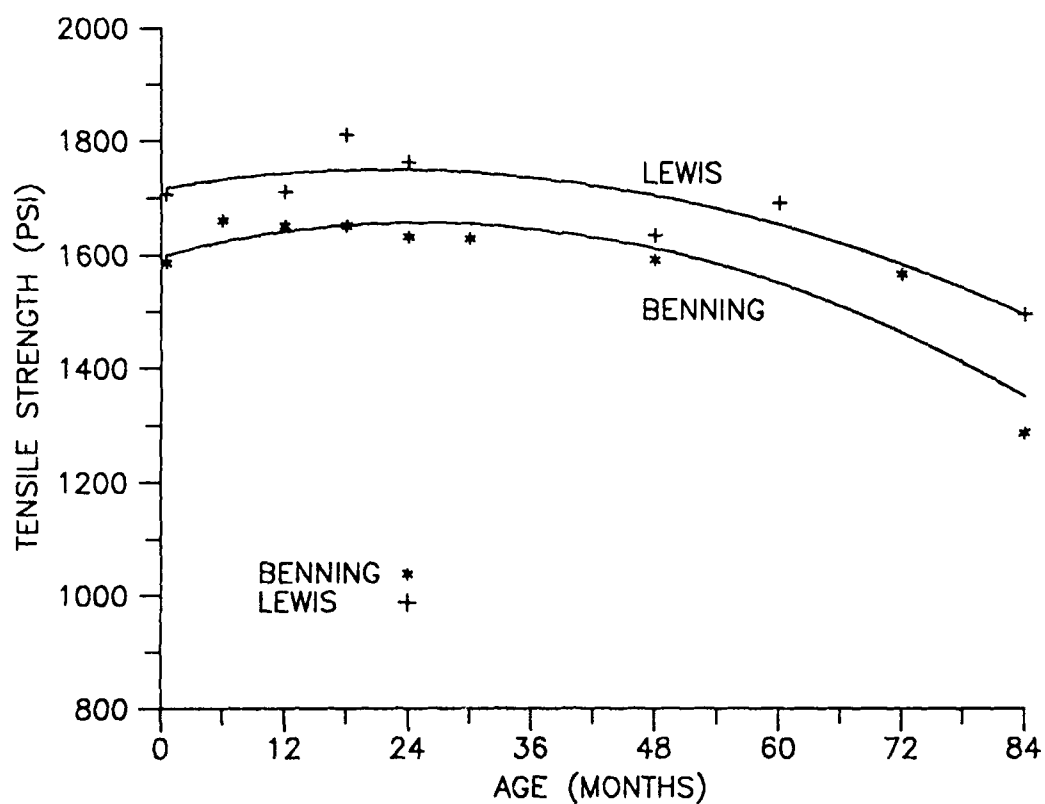
Figure 7. EPDM tensile strength.

Tests by others⁹ indicate that the EPDM roof materials display increased tensile strength, reduced elongation properties, and increased hardness after accelerated aging. Results of the field test (shown in Figures 7, 8, and 9) indicate similar effects of natural aging. There was an initial increase in tensile properties after exposure of 6 months at Fort Benning, but the succeeding tests indicate a gradual return

to just below the original value after 6 years. At Fort Lewis, an increase was evident up to 18 months with a steady drop to just below the original value after 5 years. Decrease in elongation and increase in hardness indicated long term hardening of the EPDM at both locations. The abrasion loss (Figure 10) showed a steady increase after declining during the first 3 years. Water absorption (Figure 11) of the membrane at Forts Benning and Lewis steadily increased over time, but the change is so slight as to be essentially insignificant.

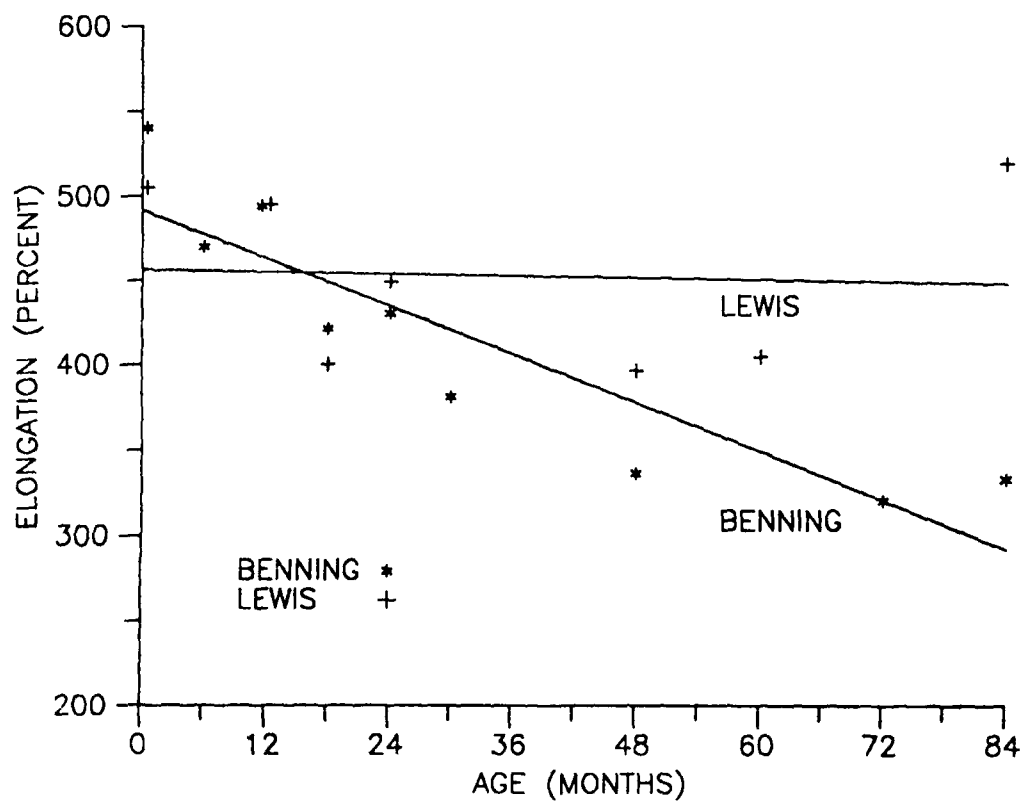
Figure 8. EPDM elongation.

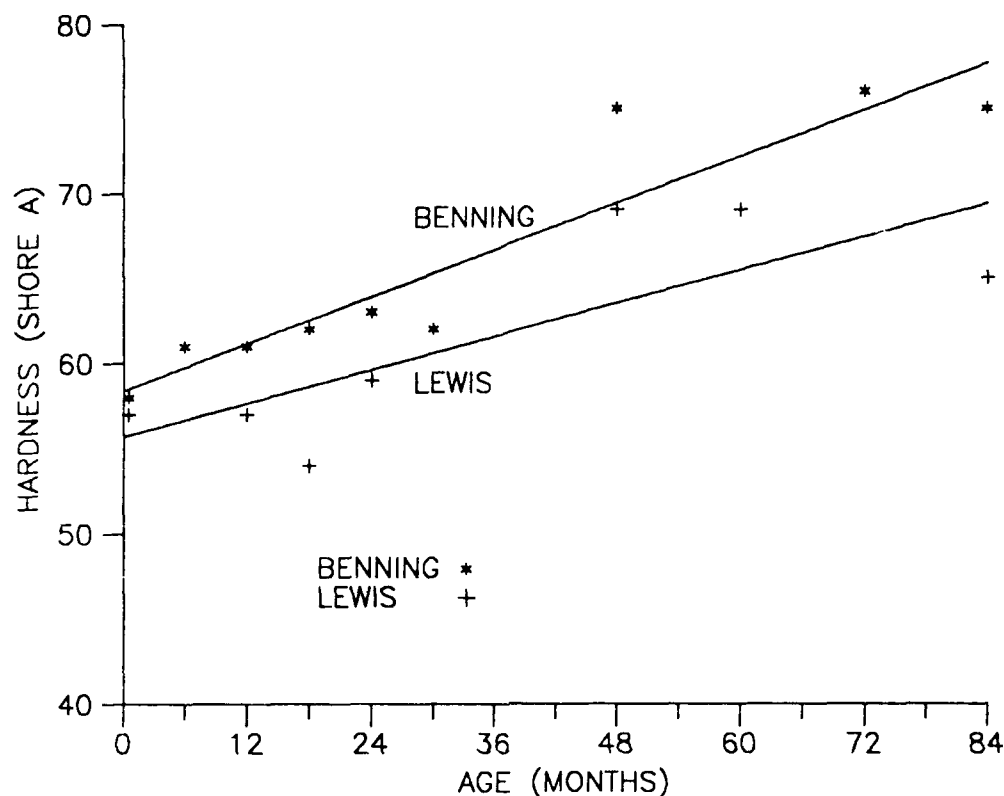
Figure 9. EPDM hardness.

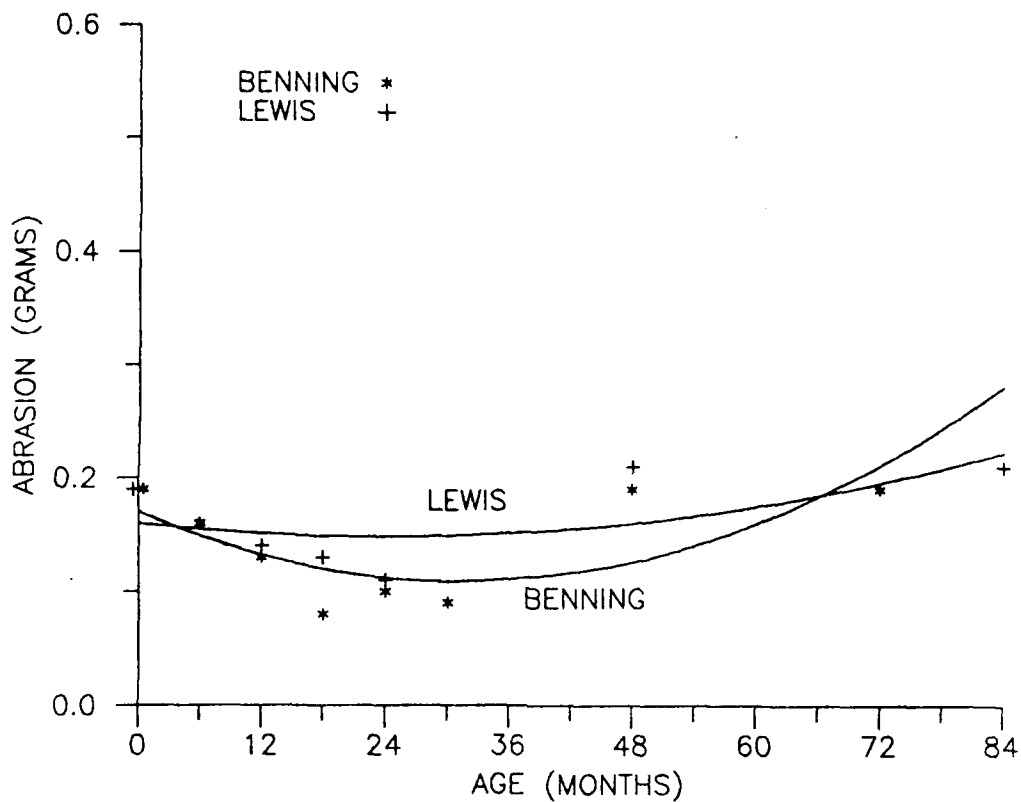
Figure 10. EPDM abrasion loss.

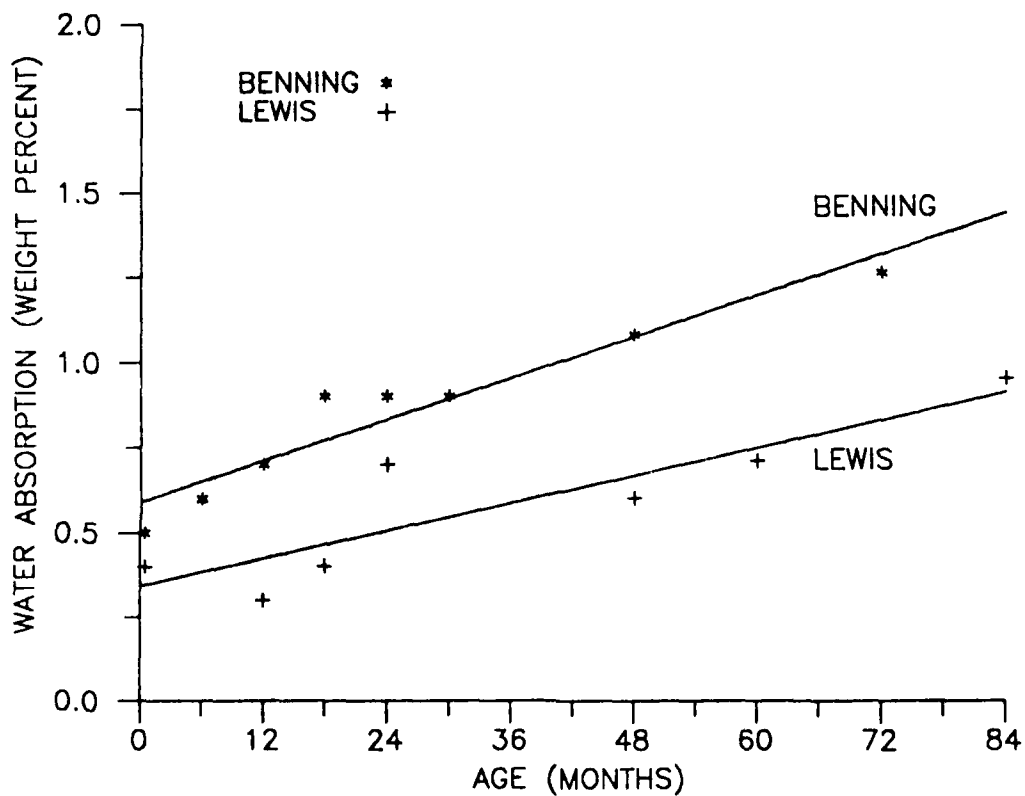
Figure 11. EPDM water absorption.

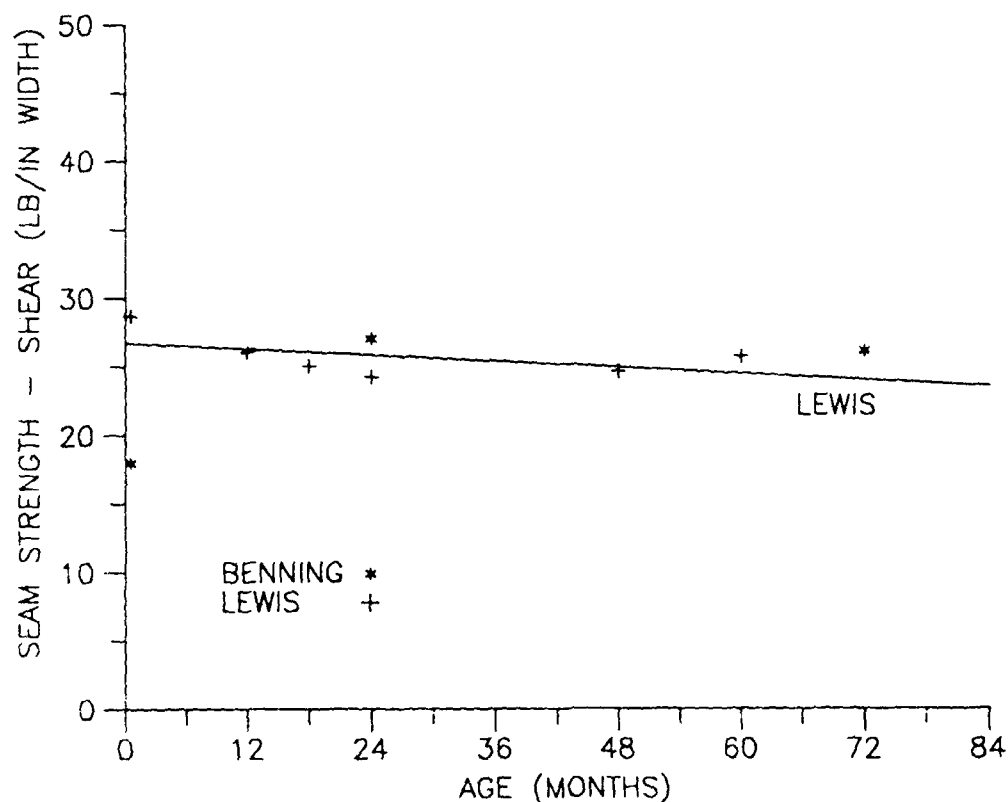
Figure 12. EPDM seam strength - shear.

Seam strength testing was performed as scheduled for the system at Fort Lewis but not at Fort Benning due to poor sample conditions. The shear strength of the seam (Figure 12) decreased to a low of 24 lb/in. width after 2 years and stabilized. The peel strength (Figure 13) dropped from an initial value of 2.5 lb/in. width to 1.9 lb/in. after 2 years and stabilized. The seams lost 16 percent of their initial strength in shear and up to 24 percent of their initial strength in peel. The drop in peel strength at Fort Lewis apparently did not affect the performance of the seams. The seams at Fort Benning were initially very weak but show a substantial increase in both peel and shear strengths with time. At both locations, the system is fully adhered, so the strength of the seams is not as important as it would be if the membrane were either loose laid or mechanically fastened. An important result of these field tests was that the original seams at both locations maintained their watertight integrity, despite the aging of the membrane surfaces, except for one seam at Fort Benning.

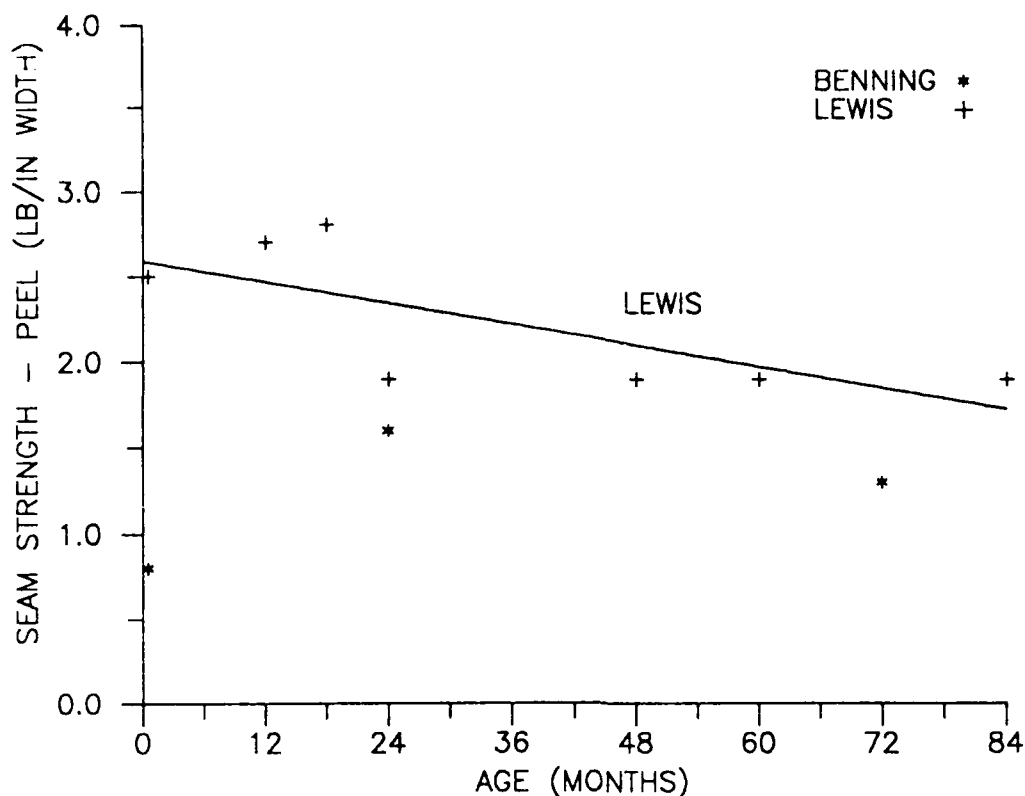
Figure 13. EPDM seam strength - peel.

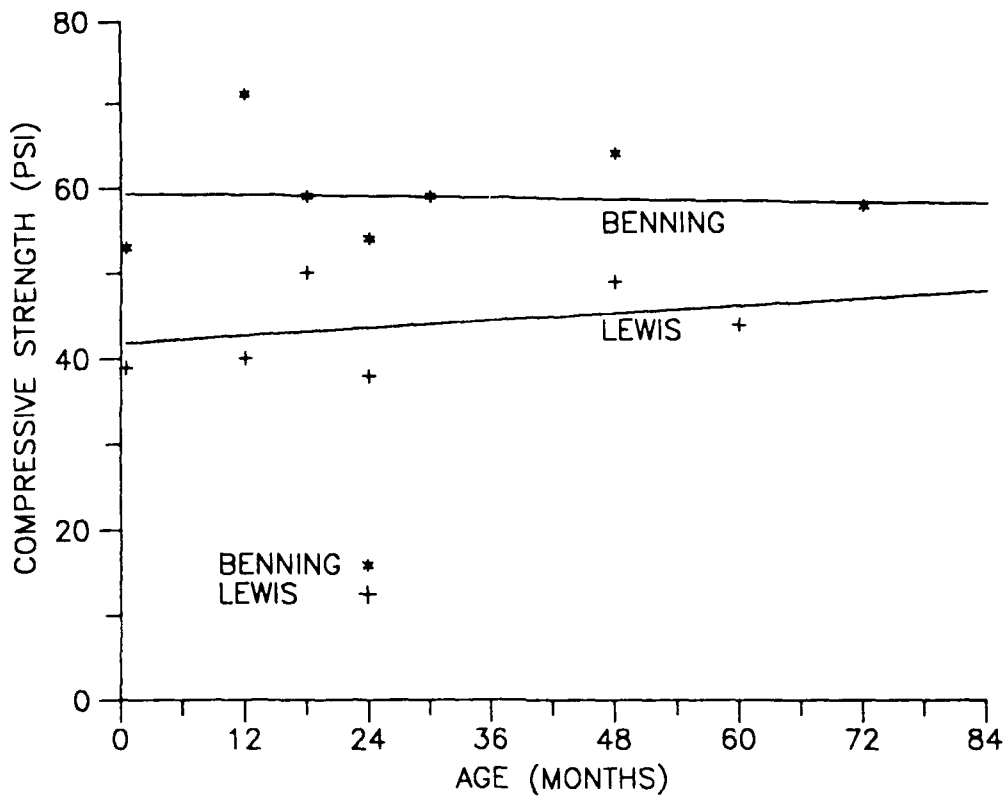
Figure 14. PUF compressive strength.

The initial and aged characteristics for the two PUF roofs can be found in Tables 9 and 10. The compressive strength (Figure 14) has shown a slight increase with time from the initial value at both locations, each staying near or above the required minimum of 40 psi. Compressive strength is an important property of the foam, as it is the one property which most resists traffic on the roof. The foam should be capable of bearing all anticipated traffic loads throughout its life. It is impossible to extrapolate the curves into the future, as more data would be required to accurately establish the trends. Tensile interlaminar strength decreased at both sites (Figure 15). The loss of tensile strength in the foam at Fort Lewis was more rapid, indicating that the specific foam used there loses its ability to adhere to itself, leading to the possibility of future separation of the layers.

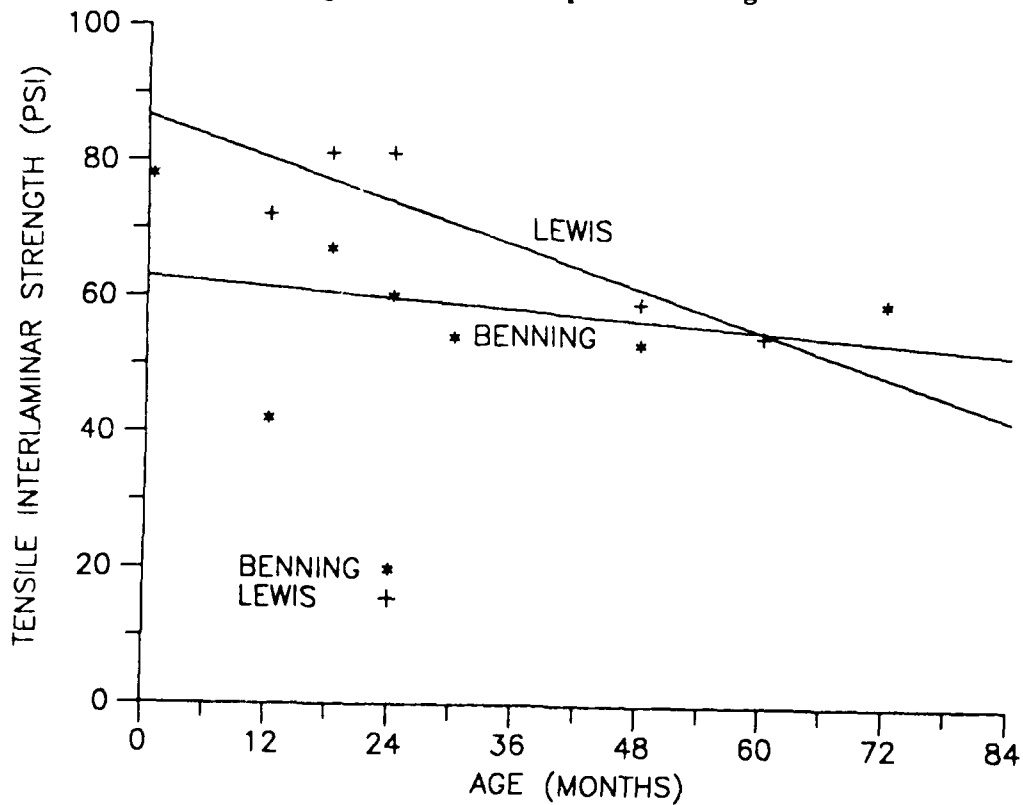
Figure 15. PUF tensile strength - interlaminar.

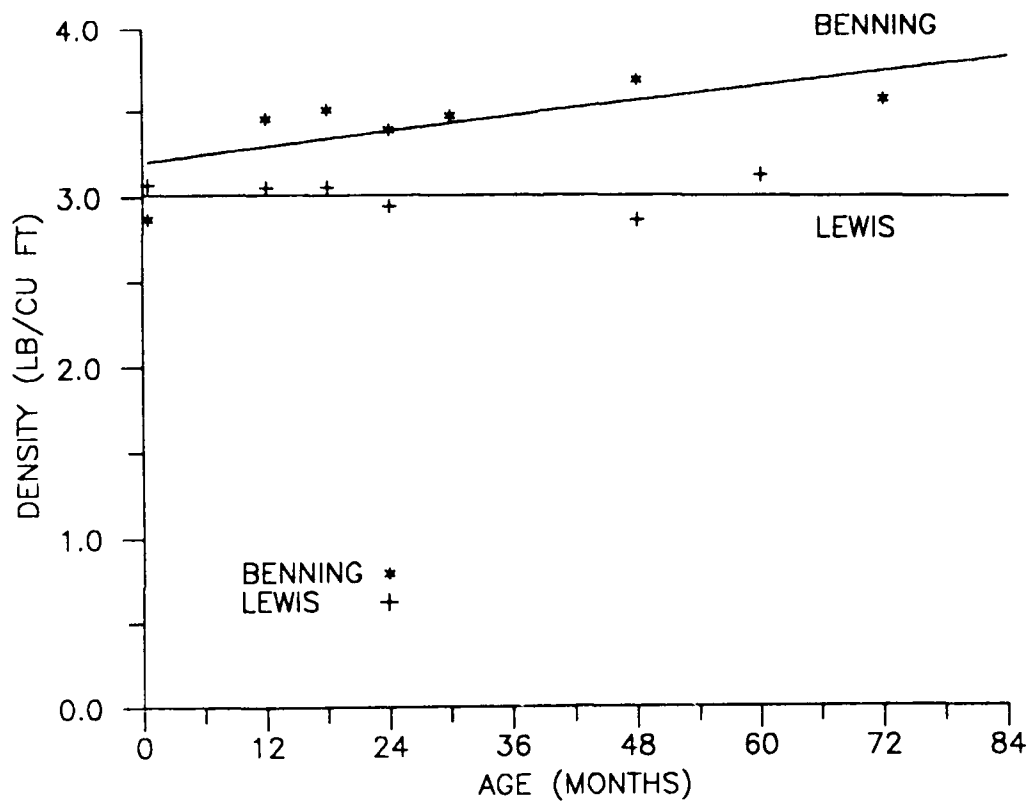
Figure 16. PUF density.

Figure 16 shows the densities of foam samples. Recommended minimum density is 2.5 lb/cu ft. This is to ensure minimum compressive strength requirements of a properly mixed spray. The foam density at Fort Lewis has remained relatively unchanged. However, at Fort Benning, the density has shown a 28 percent increase after the initial sampling.

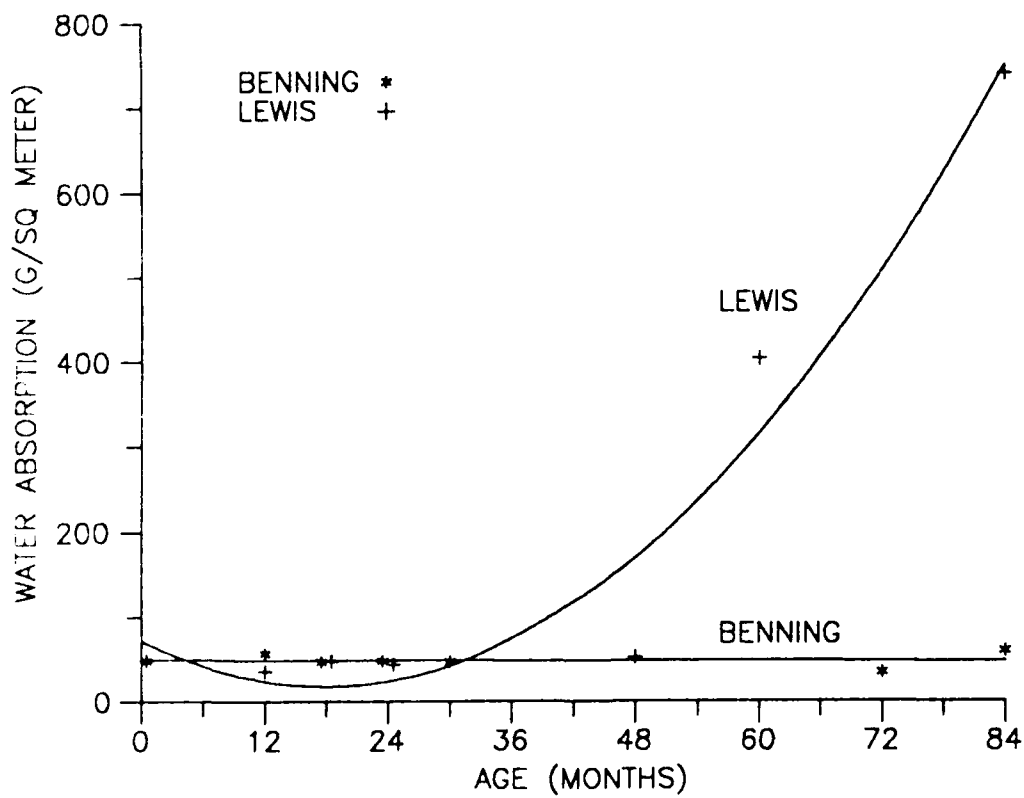
Figure 17. PUF water absorption.

Water absorption of the foam at Fort Benning (Figure 17) remained steady, staying below 60 g/m² through 7 years. At Fort Lewis the water absorption remained at approximately its initial value for 4 years and then showed a significant increase during the last 2 years.

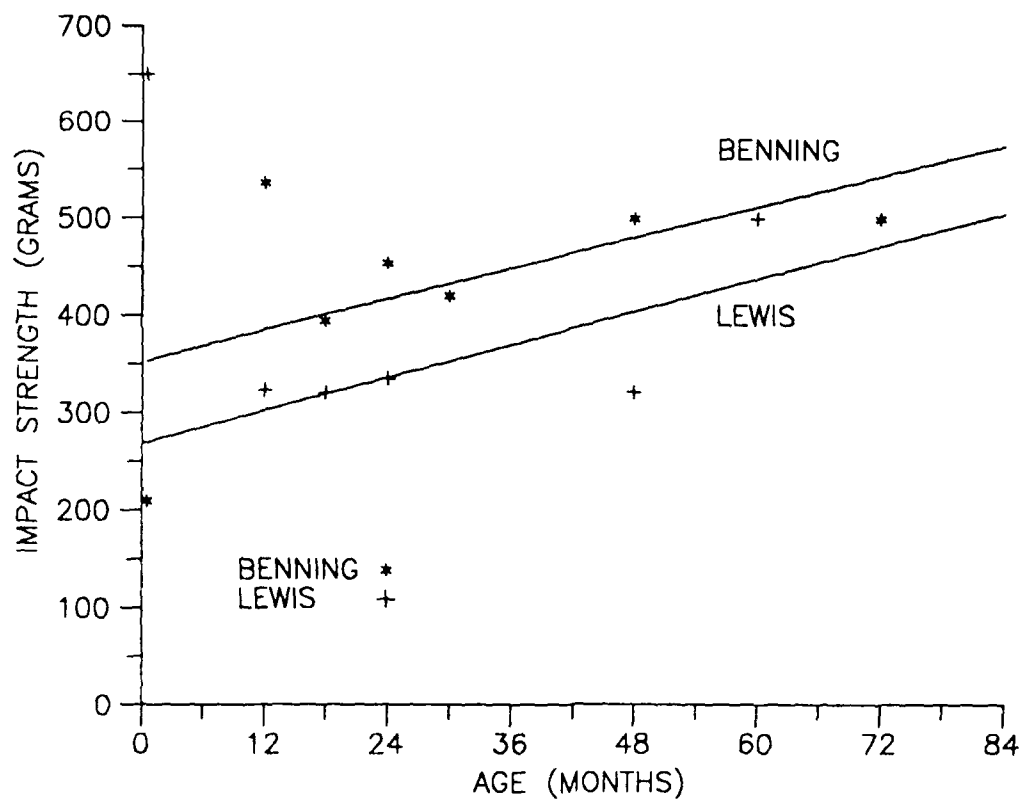
Figure 18. PUF impact strength.

Figures 18 through 20 outline changes of foam and coating assembly properties. Impact and indentation properties improved over time as coating adhesion declined. Impact strength increased at about the same rate at Fort Benning and Fort Lewis. The rate of increase in indentation strength was slightly greater at Fort Lewis. At both sites, the coating adhesion has shown a large decrease. Despite this degradation, visual inspections have not shown any significant occurrences of blisters within the foam/coating interface or peeling of the coating.

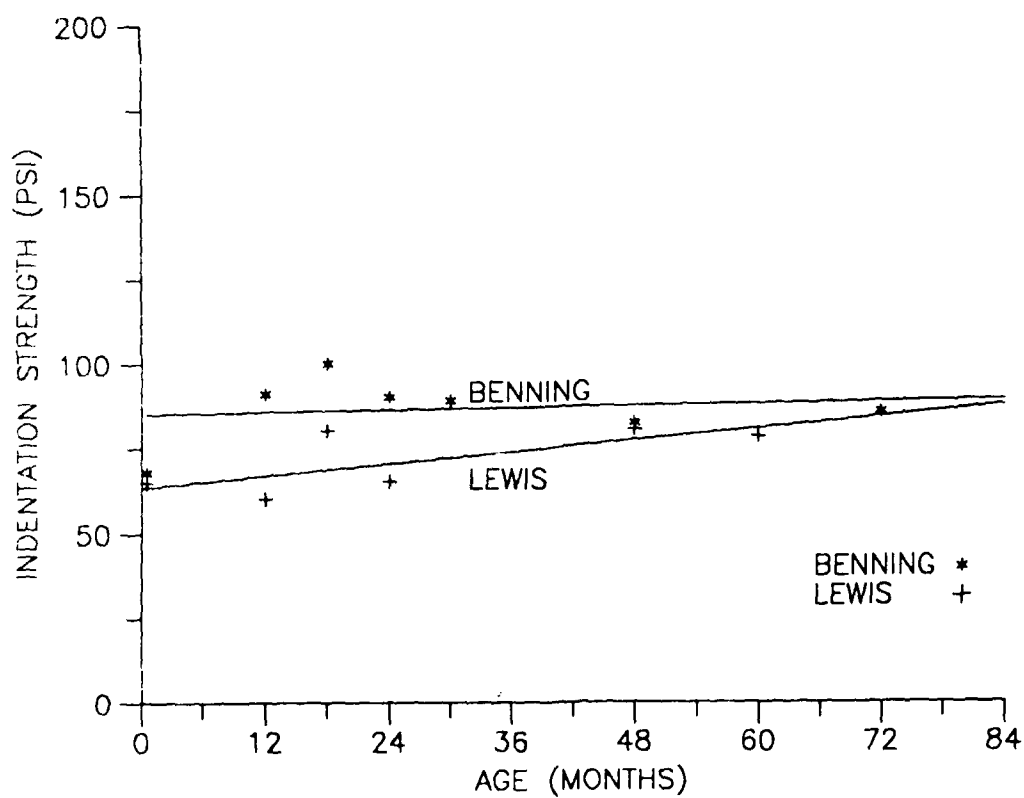
Figure 19. PUF indentation strength.

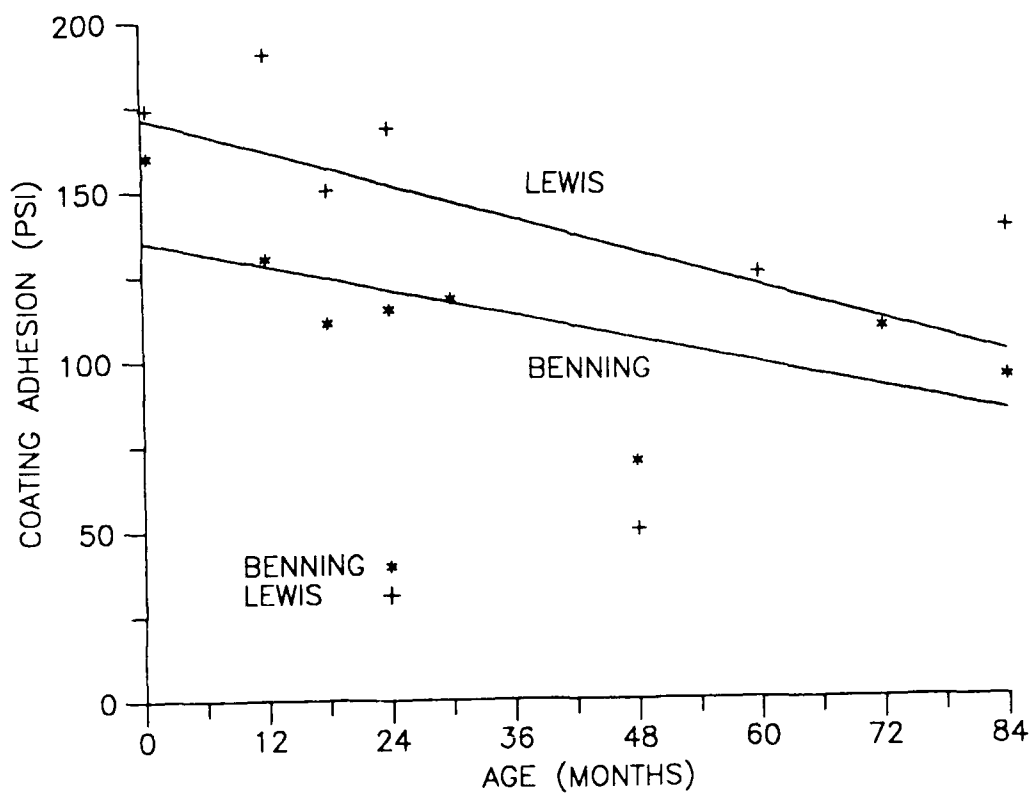
Figure 20. PUF coating adhesion.
